# Safety Bulletin 2 /2024

## Small tweak, big difference

### Heavy objects dropped

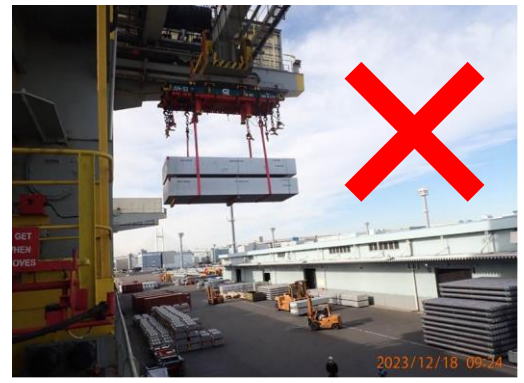
The crane's direction of travel is abeam, not fore-and aft. Abrupt crane movements can always occur, because of a mistake by the crane operator or a technical malfunction. If it happens, the cargo is much more likely to slide out of the slings, if the direction of the cargo is as shown in the in the top right corner.

- Consider the orientation of slabs, and all other types of cargo. Use the safer option, even if it adds a few seconds to each lifting operation.
- Assess risk. Sometimes a minor tweak in working method can significantly reduce risk. Having more than one safety barrier will ensure that a single human error or a minor technical malfunction does not have catastrophic consequences.
- Never walk under a suspended load. Make it a habit to walk on the sea-side when the vessel is alongside. Avoid the side facing the quay, where cargo operations are ongoing.
