# Safety Bulletin 8 /2023

## Crush injuries

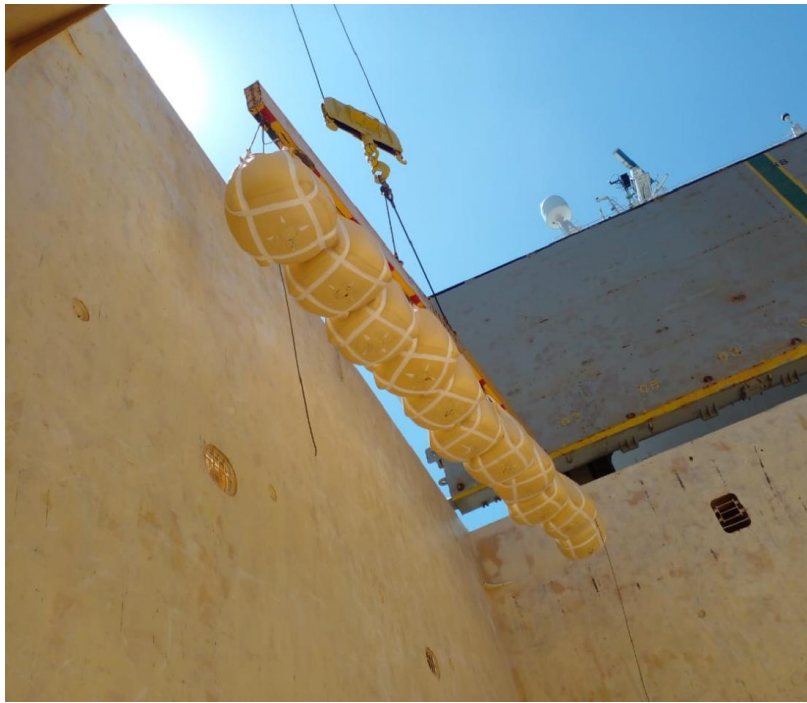
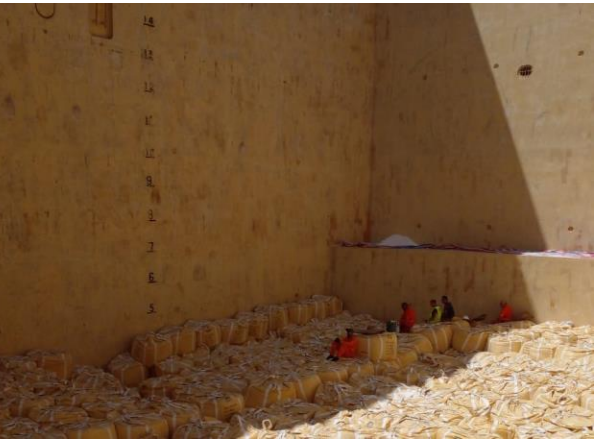
Stevedores were inside the cargo hold, hooking up bags to the spreader beam.

Big bags of soda ash were discharged. A stevedore was standing between the spreader beam and the bulkhead, when there was a sudden, unexpected movement of the beam. The stevedore's rib cage was momentarily pressed between the beam and the bulkhead.

In this case the stevedore suffered minor injuries. He was conscious when taken to hospital for examination. Considering the weight of the spreader, there was a potential for much more severe injuries.

- Always be aware of your surroundings. Identify potential hazards, including moving objects.
